Manhole Inspection Summary

Manhole # S29WW_032MH

Insp Date: **5/16/07 10:07 AM**

Location Address: **3108 KESWICK RD**

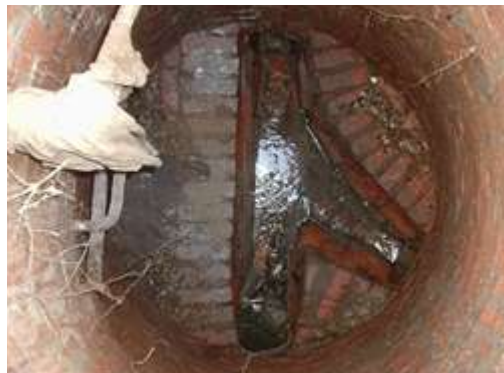
Top View

Corroded steps. Bench and Channel debris.

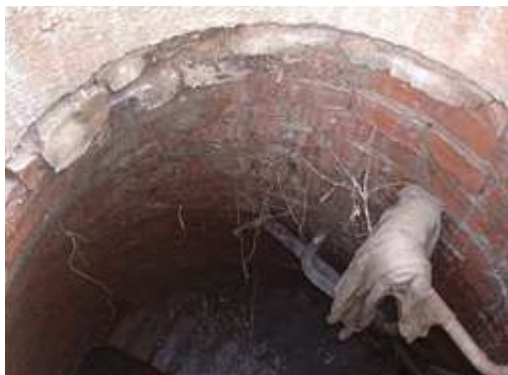
Defect

Frame leaks. Adjustment deterioration, root intrusion and infiltration. Corbel and Barrel root intrusion and infiltration - other

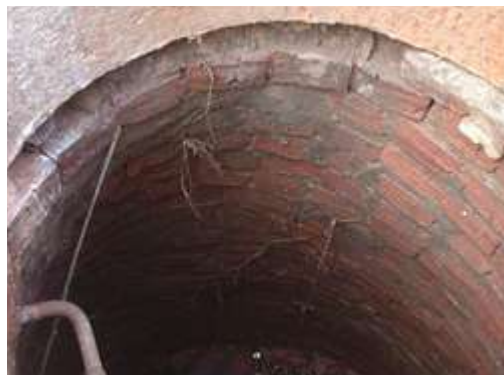
Defect

Frame leaks. Adjustment deterioration, root intrusion, loose brick and infiltration. Corbel and Barrel root intrusion and

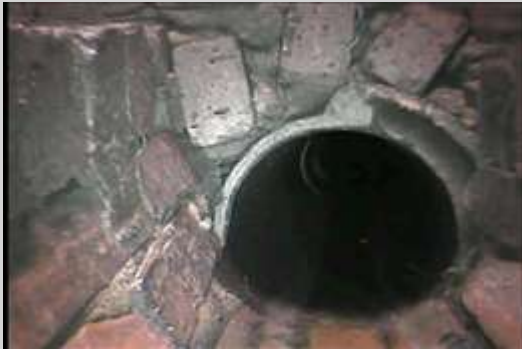
8 in. Circular Gravity Sewer Pipe Out @ 12 O'Clock

Barrel deterioration and infiltration.

Infiltration: **None** Pipe Seal Cond: **Broken**

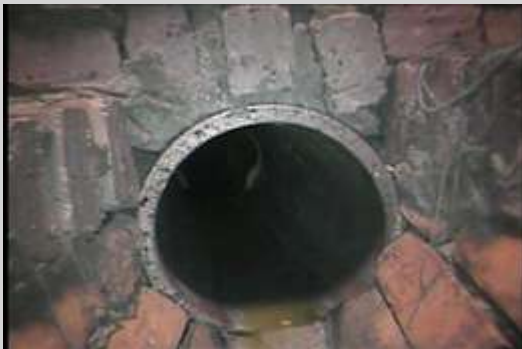
8 in. Circular Gravity Sewer Pipe In @ 4 O'Clock

Infiltration: **None** Pipe Seal Cond: **Cracked**

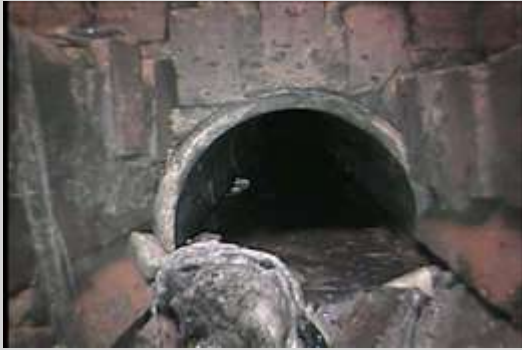
Pipe In @ 6 O'Clock

Channel deterioration.

Deposits: ☐ None ☒ **Mud** ☐ Sludge ☒ **Debris** ☐ Grease

Infiltration: **Evidence**
